West Virginia Chemical Leak
Etowah, Kanawha County, West Virginia
TDD No TL01-14-01-001

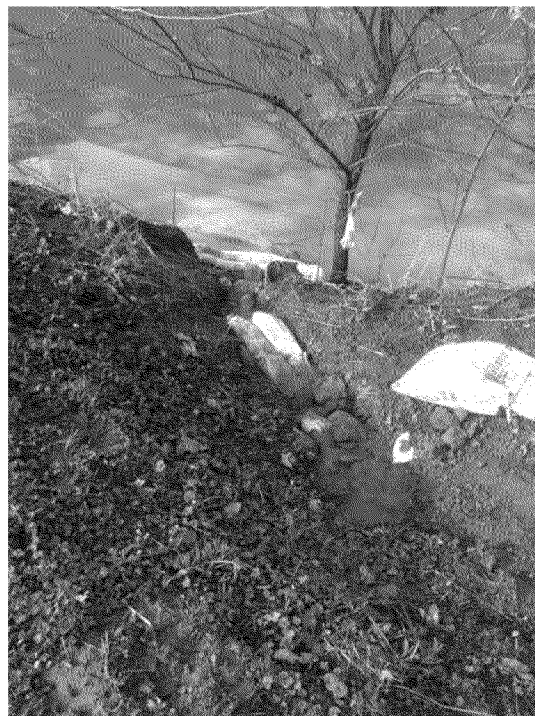
Photo No. IMG_1042; Taken on 01/10/14 at 13:10 hours by START GN. Location where storm water suspected to be contaminated with MCHM originating from under tank pad drains into Elk River.

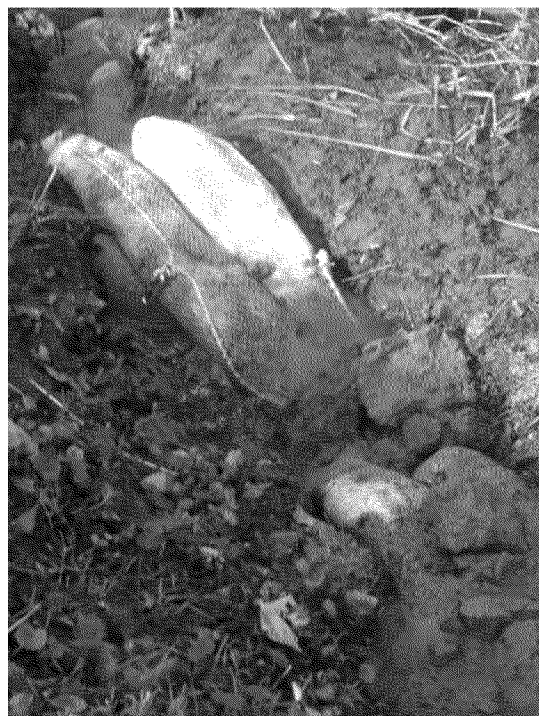
Photo No. IMG_1043; Taken on 01/10/14 at 13:10 hours by START GN. Location where storm water suspected to be contaminated with MCHM originating from under tank pad drains into Elk River.

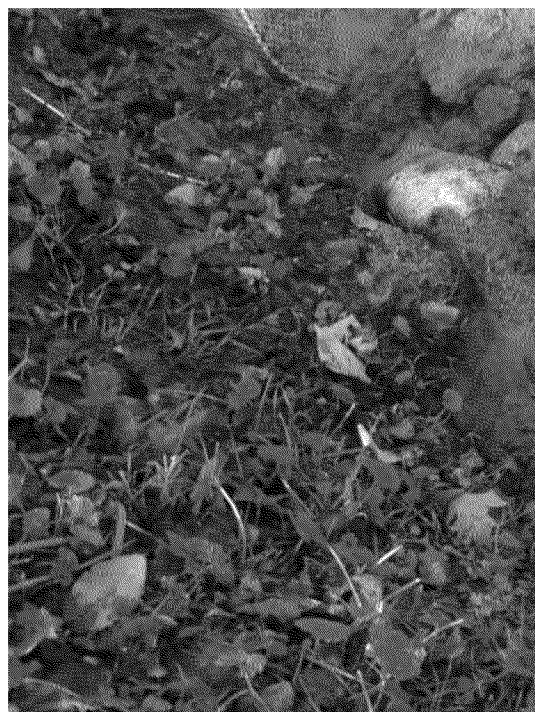
Photo No. IMG_1044; Taken on 01/10/14 at 13:10 hours by START GN. Floating material suspected to be MCHM in stormwater in ditch discharging to Elk river.

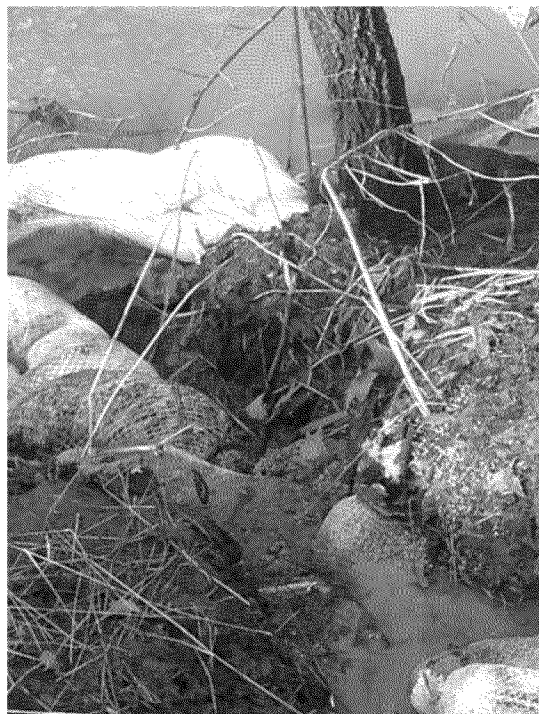
Photo No. IMG_1045; Taken on 01/10/14 at 13:11 hours by START GN. Floating material suspected to be MCHM in stormwater in ditch discharging to Elk river.

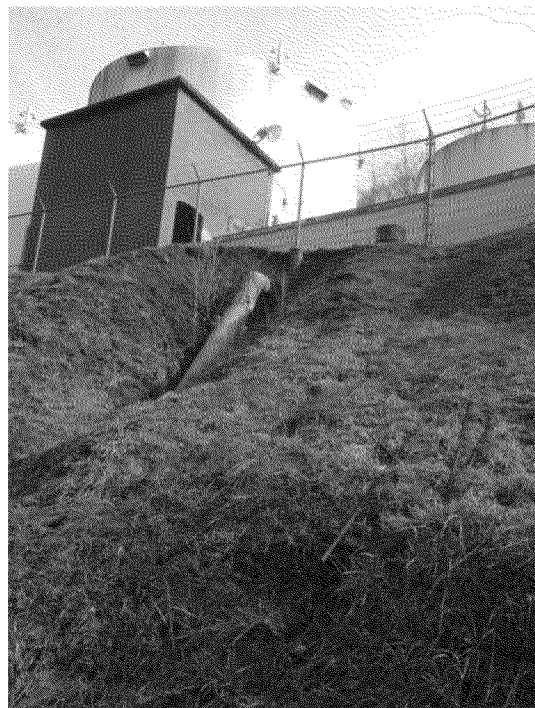
Photo No. IMG_1046; Taken on 01/10/14 at 13:11 hours by START GN. Storm water pipe that conveys water underneath tank farm. Pipe is leaking. This water was discharging to Elk river.

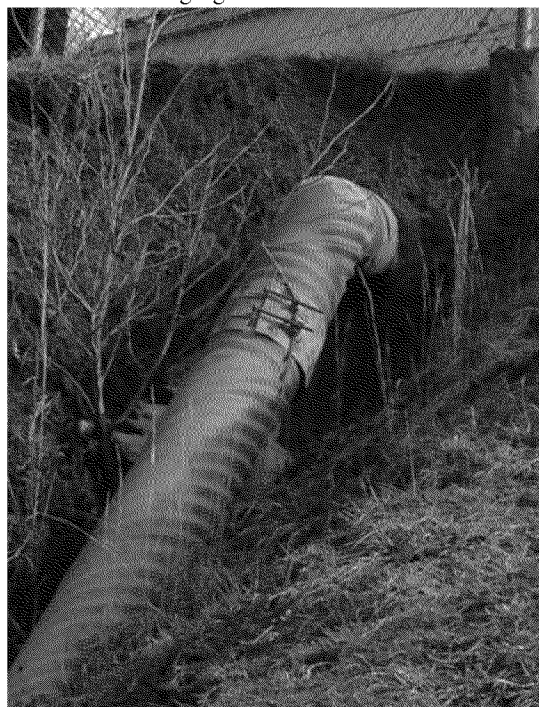
Photo No. IMG_1047; Taken on 01/10/14 at 13:13 hours by START GN. Storm water pipe that conveys water underneath tank farm. Pipe is leaking. This water was discharging to Elk river.

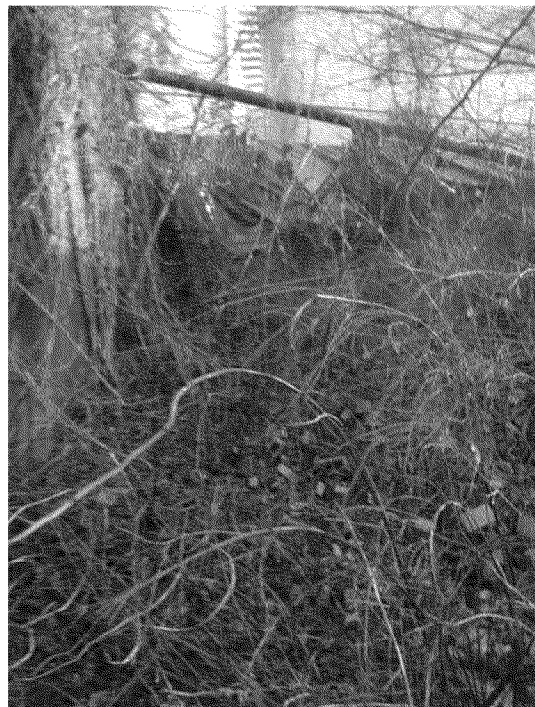
Photo No. IMG_1048; Taken on 01/10/14 at 13:13 hours by START GN. Hillside where DEP reported that original release migrated toward River.

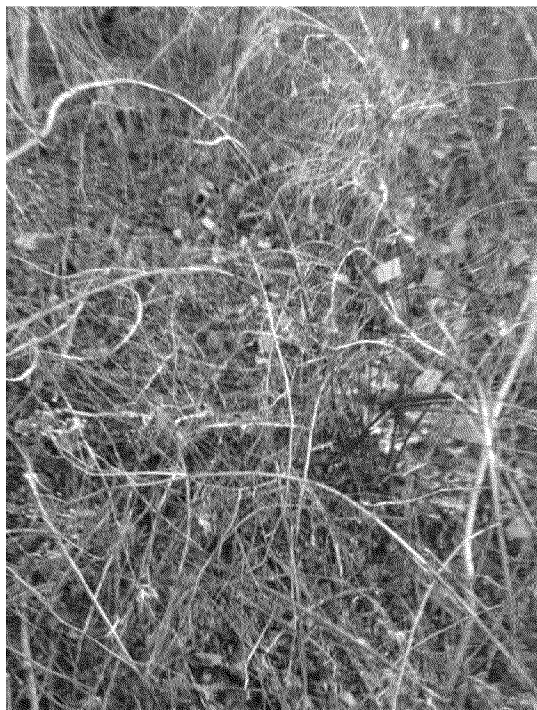
Photo No. IMG_1049; Taken on 01/10/14 at 13:13 hours by START GN. Hillside where DEP reported that original release migrated toward River (close up).

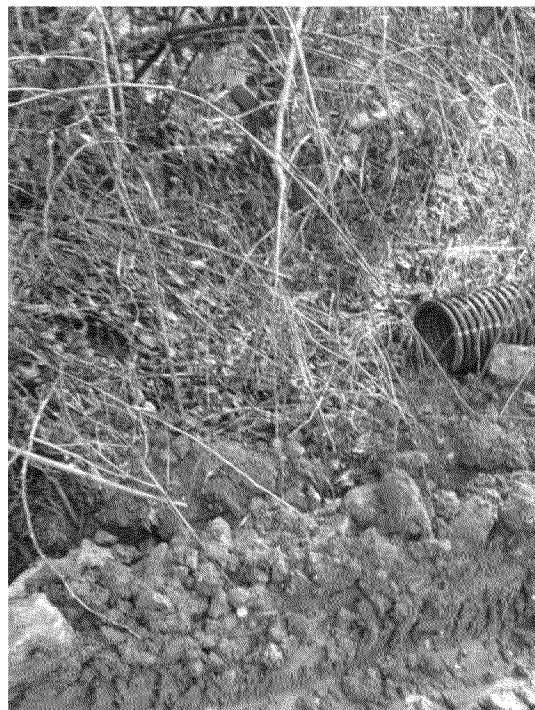
Photo No. IMG_1050; Taken on 01/10/14 at 13:14 hours by START GN. Hillside where DEP reported that original release migrated toward River (close up).

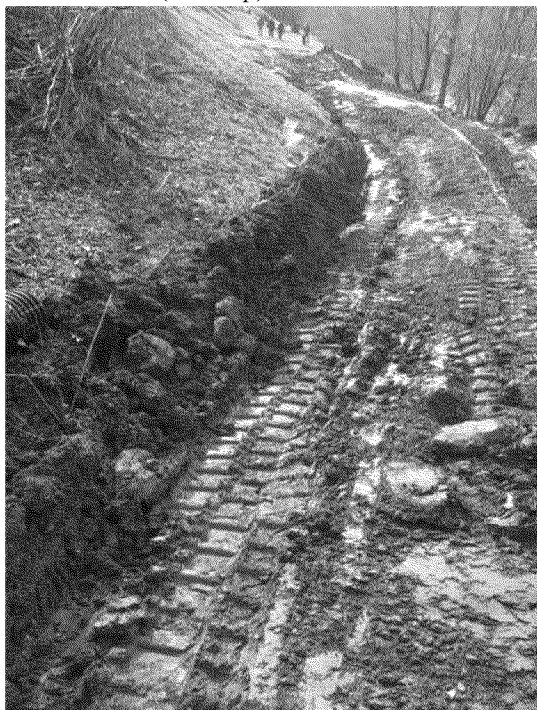
Photo No. IMG_1051; Taken on 01/10/14 at 13:43 hours by START GN. Interceptor trench/sump constructed at bottom of the hill to contain storm water.

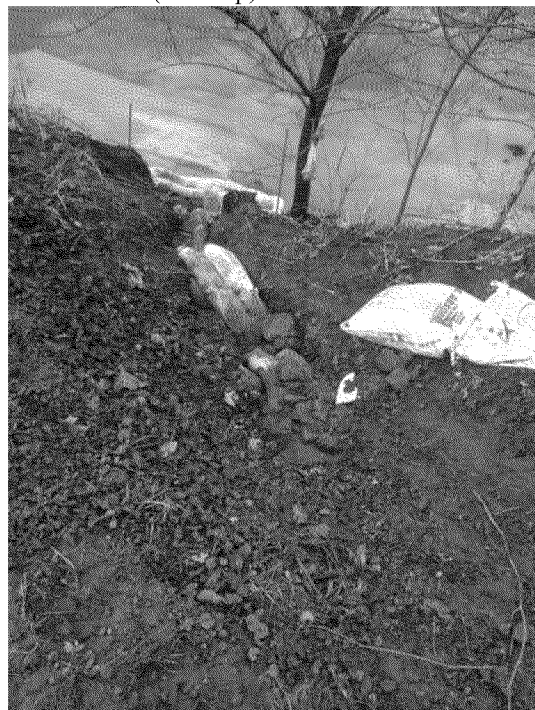
Photo No. IMG_1052; Taken on 01/10/14 at 13:43 hours by START GN. Storm water migration pathway to River. Water flow to River stopped after trench deepened and dug out below pipe.

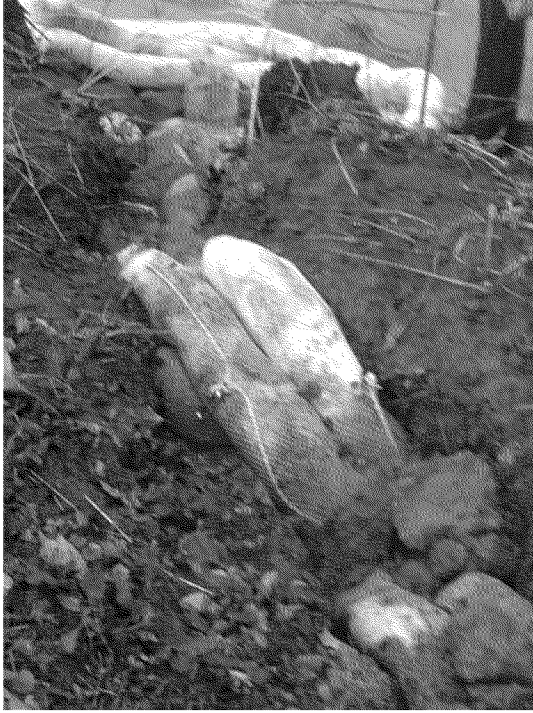
Photo No. IMG_1053; Taken on 01/10/14 at 13:43 hours by START GN. Storm water migration pathway to River. Water flow to River stopped after trench deepened and dug out below pipe.

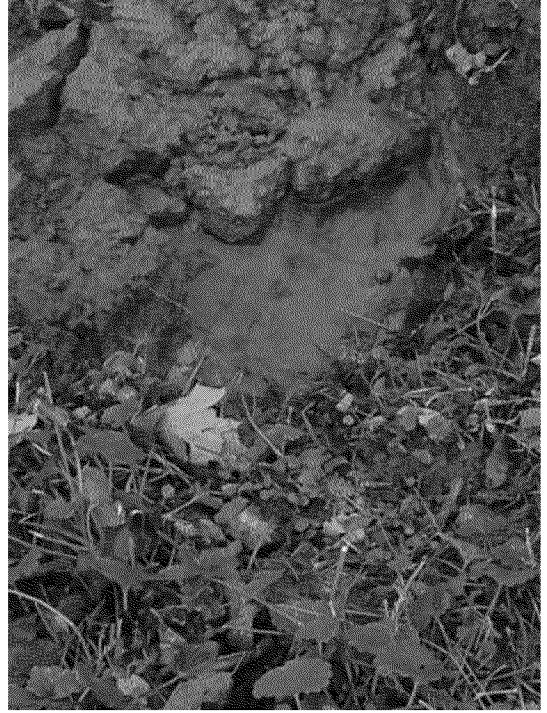
Photo No. IMG_1054; Taken on 01/10/14 at 13:45 hours by START GN. Water in drainage path to river.

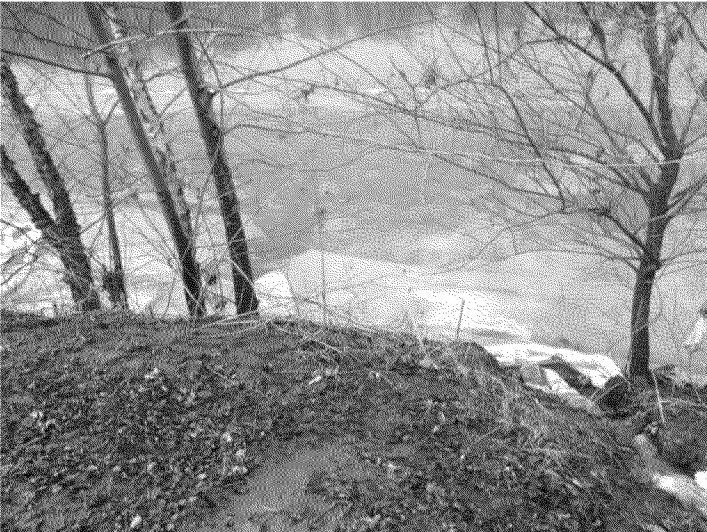
Photo No. IMG_1055; Taken on 01/10/14 at 13:45 hours by START GN. Ice at river edge with what appears to be product trapped under it.

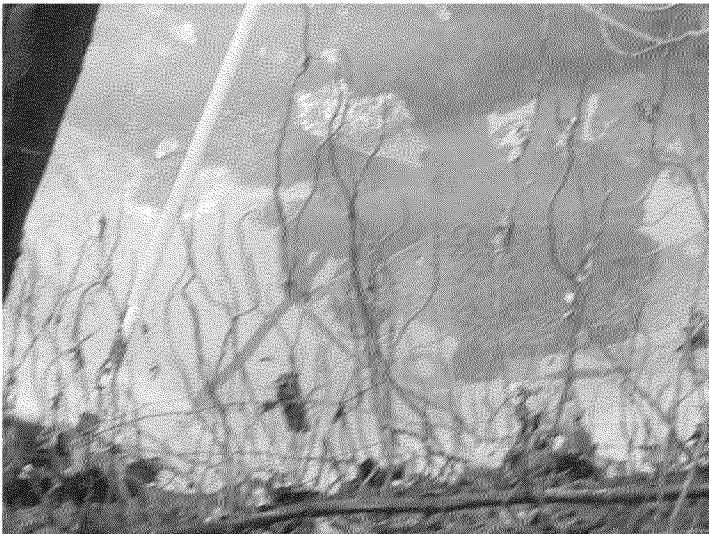
Photo No. IMG_1059; Taken on 01/10/14 at 14:12 hours by
START GN. MCHM globules trapped under ice at edge of river.

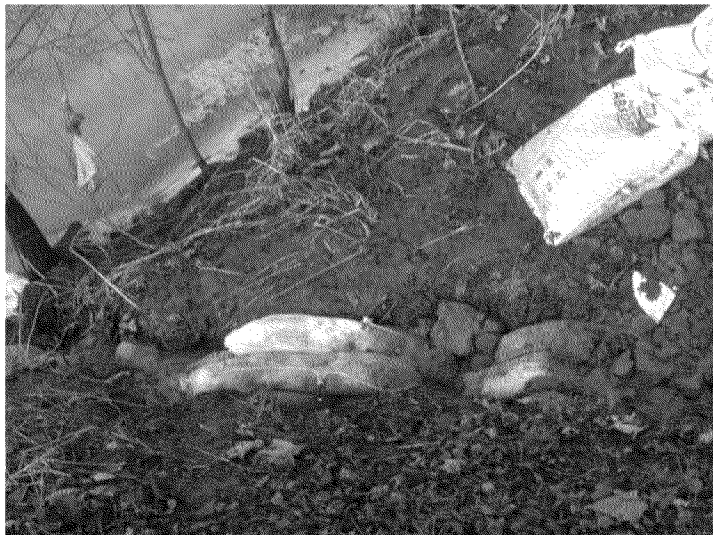
Photo No. IMG_1061; Taken on 01/10/14 at 15:58 hours by START GN. MCHM globules trapped under ice at edge of river. No water flow in drainage pathway

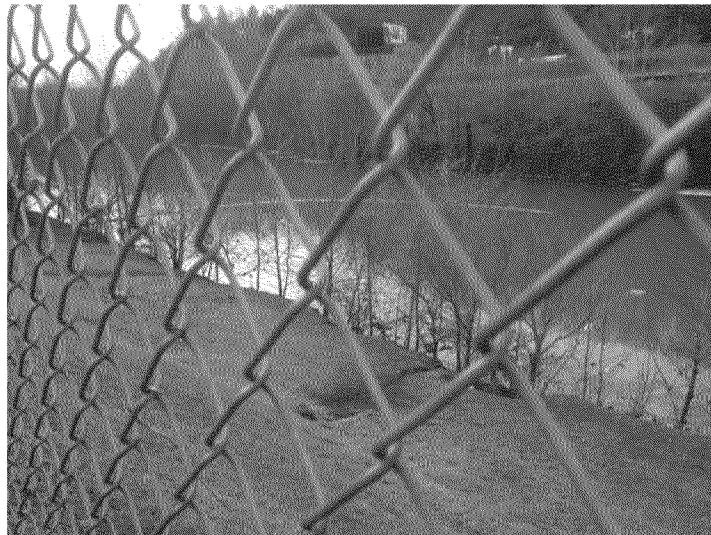
Photo No. IMG_1062; Taken on 01/10/14 at 15:58 hours by START GN. River boom deployed in Elk river downstream of release area.

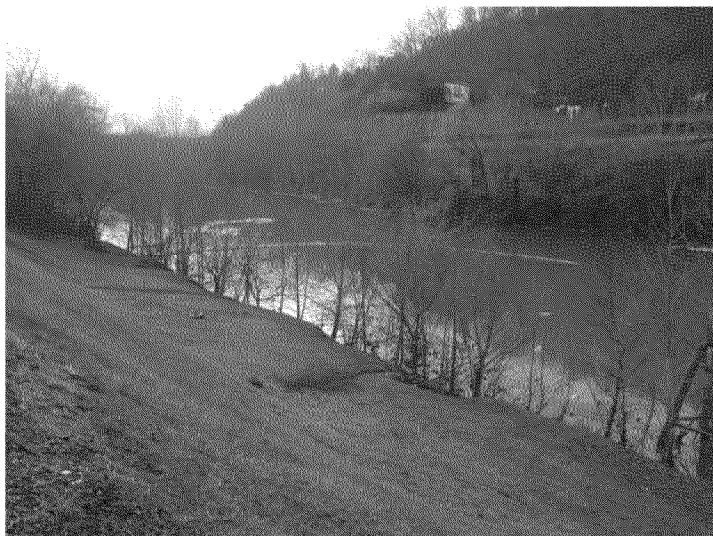
Photo No. IMG_1063; Taken on 01/10/14 at 13:58 hours by START GN. River boom deployed in Elk river downstream of release area.

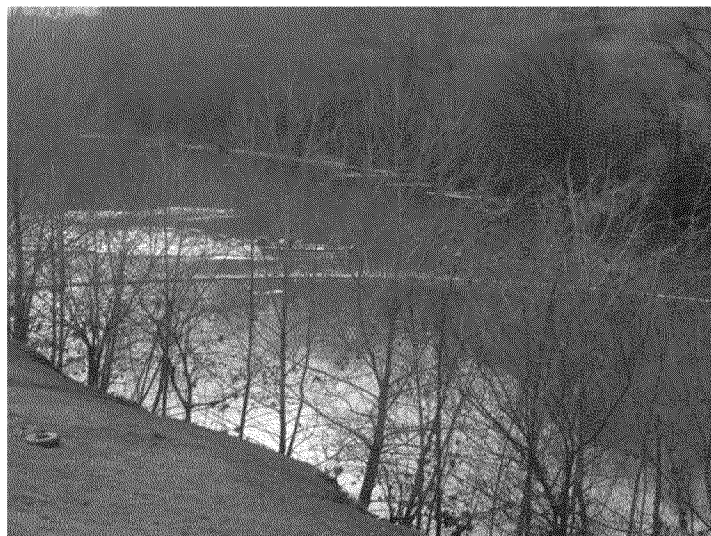
Photo No. IMG_1064; Taken on 01/10/14 at 16:06 hours by START GN. River boom deployed in Elk river downstream of release area.

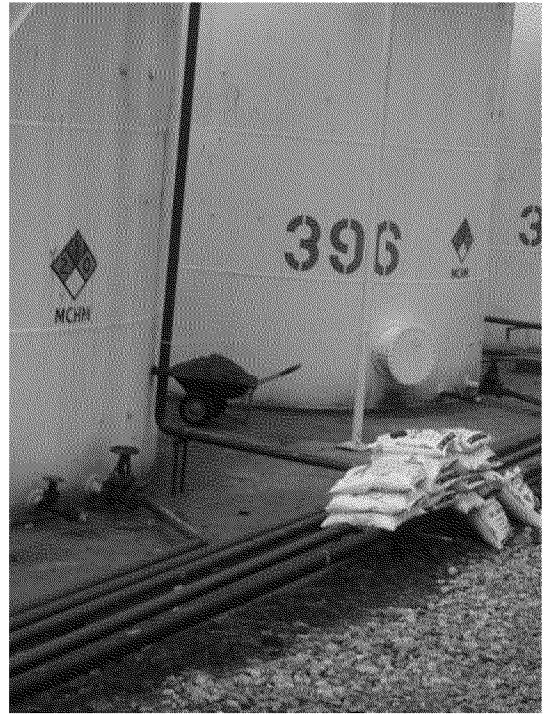
Photo No. IMG_1066; Taken on 01/10/14 at 16:07 hours by START GN. MCHM tank 396, from which release occurred.

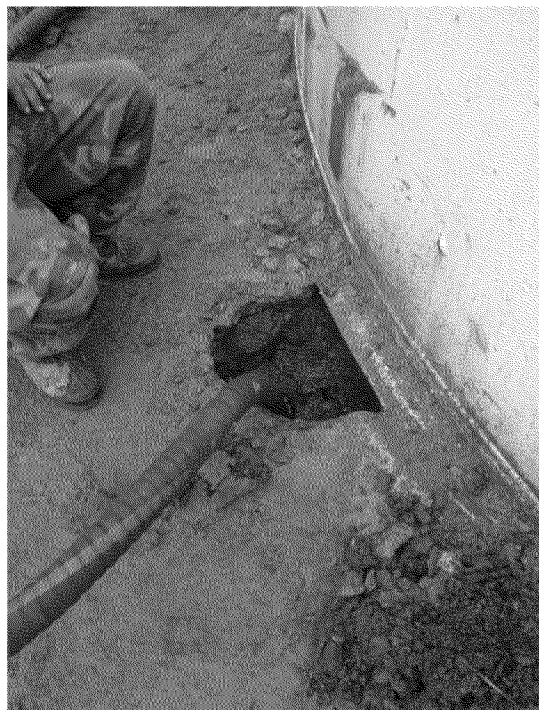
Photo No. IMG_1069; Taken on 01/10/14 at 16:18 hours by START GN. Vacuuming water and MCHM product from sump/hole at location of release.

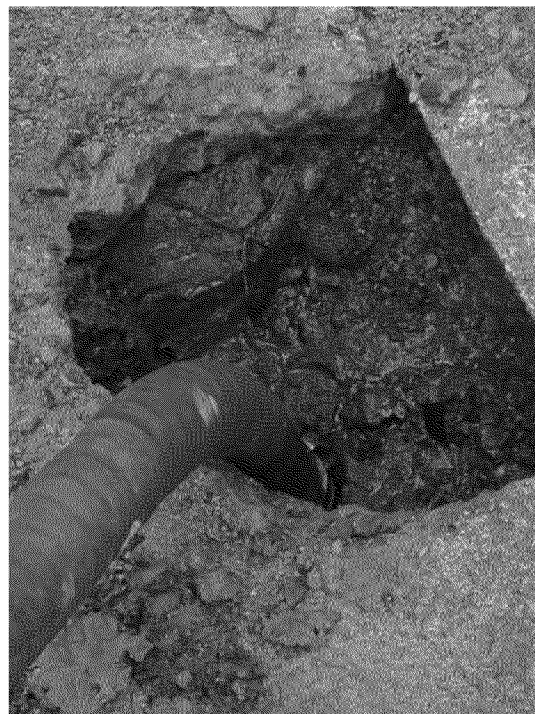
Photo No. IMG_1070; Taken on 01/10/14 at 16:20 hours by START GN. Vacuuming water and MCHM product from sump/hole at location of release.

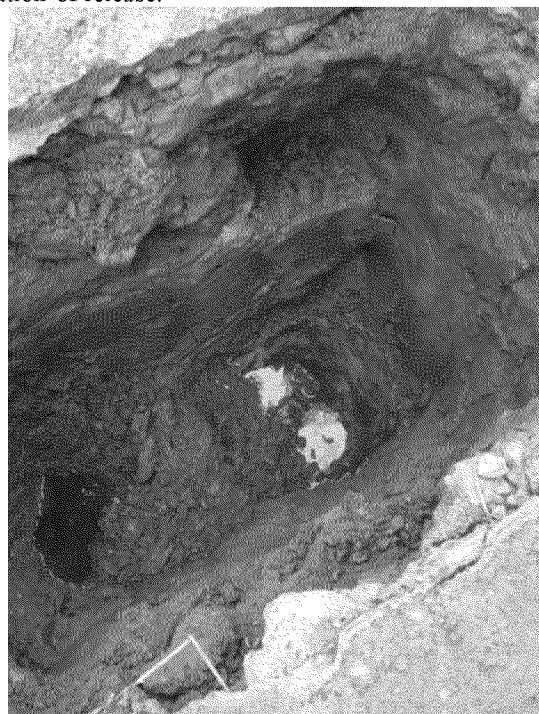
Photo No. IMG_1071; Taken on 01/10/14 at 16:20 hours by START GN. Water and MCHM product in 5-ft. sump dug inside tank containment area.

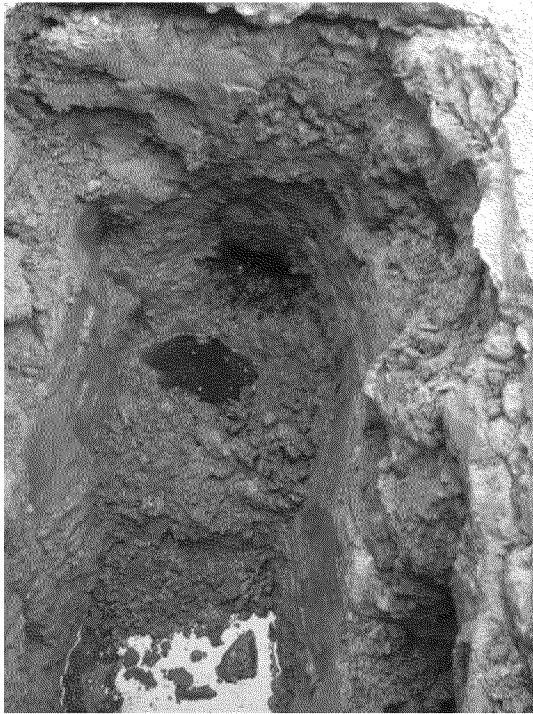
Photo No. IMG_1073; Taken on 01/10/14 at 16:27 hours by START GN. Water and MCHM product accumulating in 5-ft. sump, entering from under a pipe.

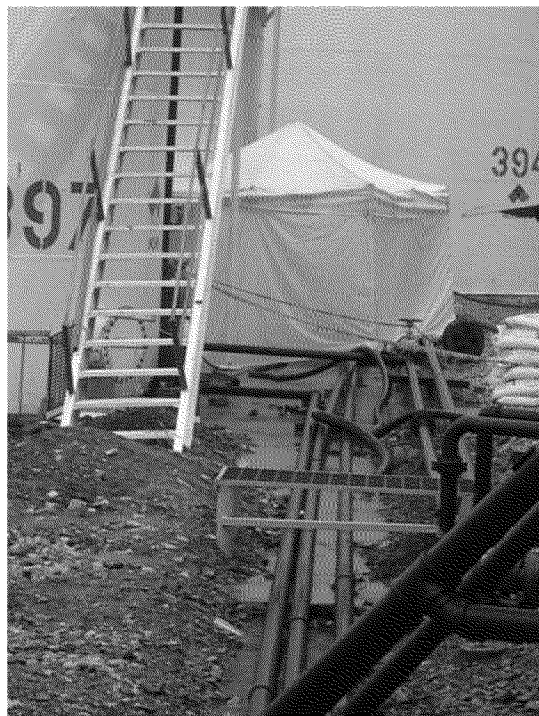
Photo No. IMG_1078; Taken on 01/11/14 at 9:47 hours by START GN. Tent set up at manway into Tank 396 (release tank).

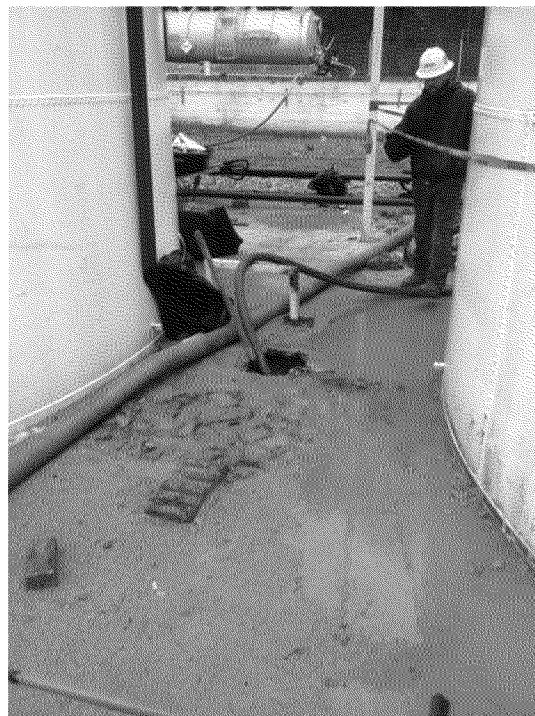
Photo No. IMG_1079; Taken on 01/11/14 at 9:49 hours by START GN. Vacuuming water/product from hole/sump.

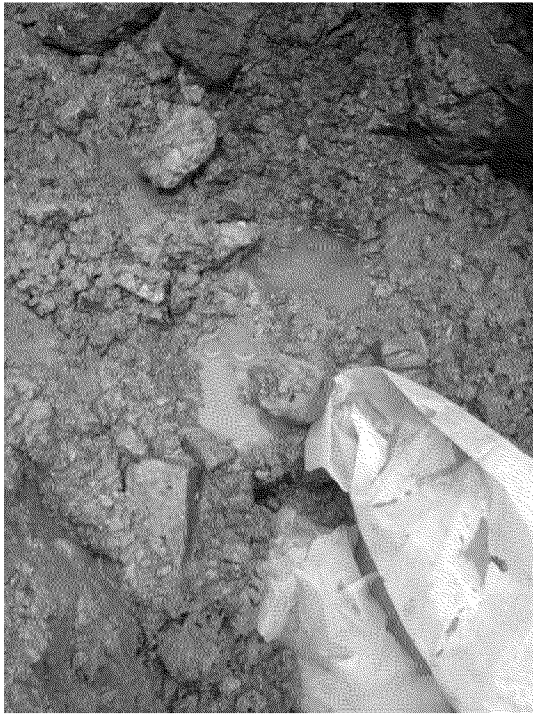
Photo No. IMG_1082; Taken on 01/11/14 at 9:50 hours by START GN. Water and product in bottom of sump in tank containment area.

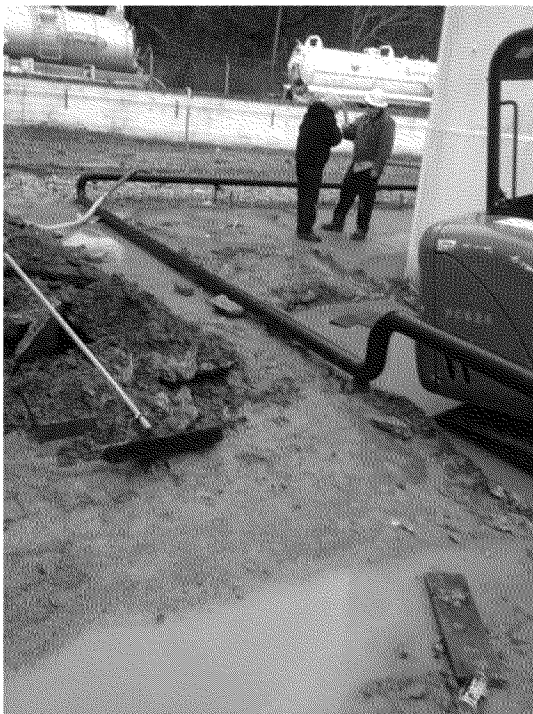
Photo No. IMG_1084; Taken on 01/11/14 at 9:52 hours by START GN. excavated area in Tank containment area.

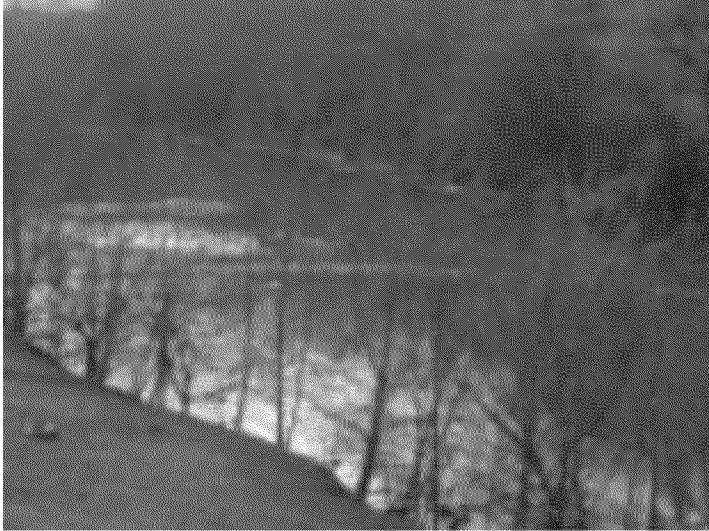
Photo No. IMG_1064; Taken on 01/11/14 at 9:37 hours by START GN. Boom deployed in river.

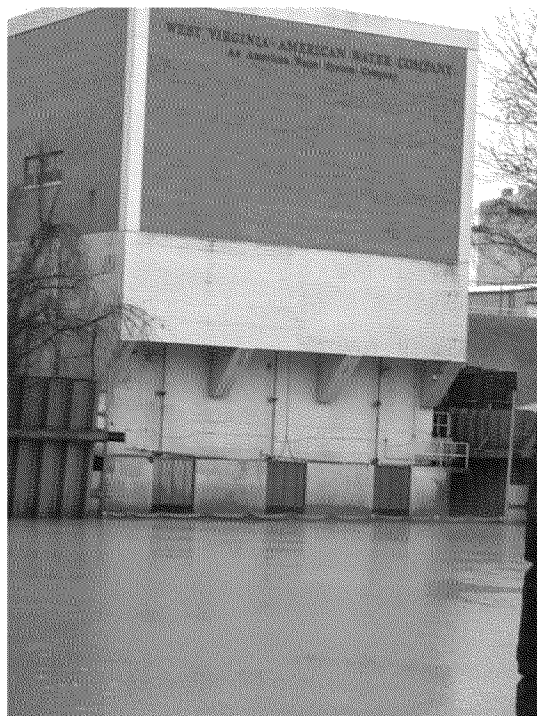
Photo No. IMG_1087; Taken on 01/11/14 at 11:25 hours by START GN. Pre-existing river boom at WV American water intake.

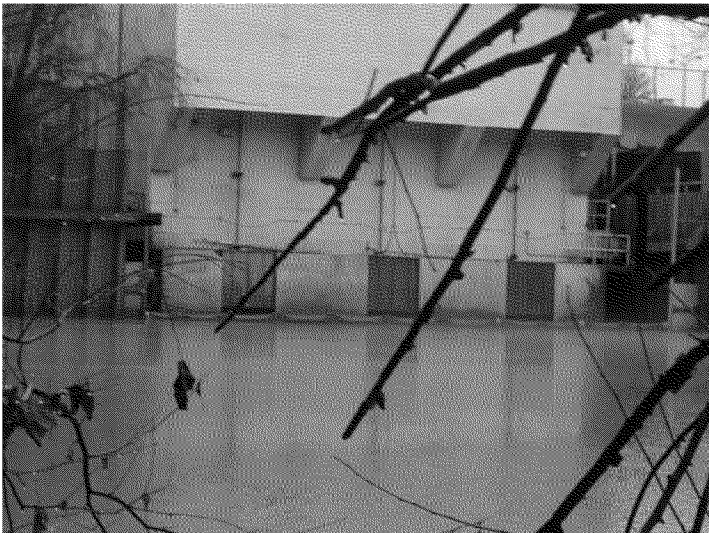
Photo No. IMG_1091; Taken on 01/11/14 at 12:21 hours by
START GN. Pre-existing river boomat WV American water
intake.

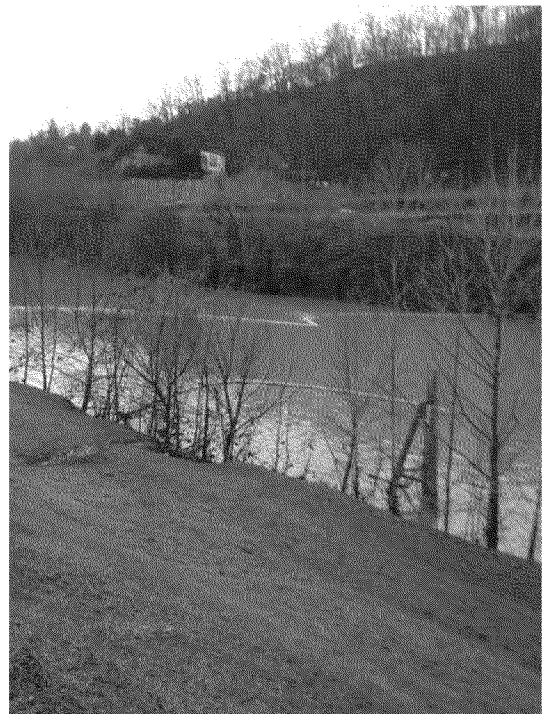
Photo No. IMG_1092; Taken on 01/11/14 at 12:21 hours by
START GN. River boom deployed in Elk river.

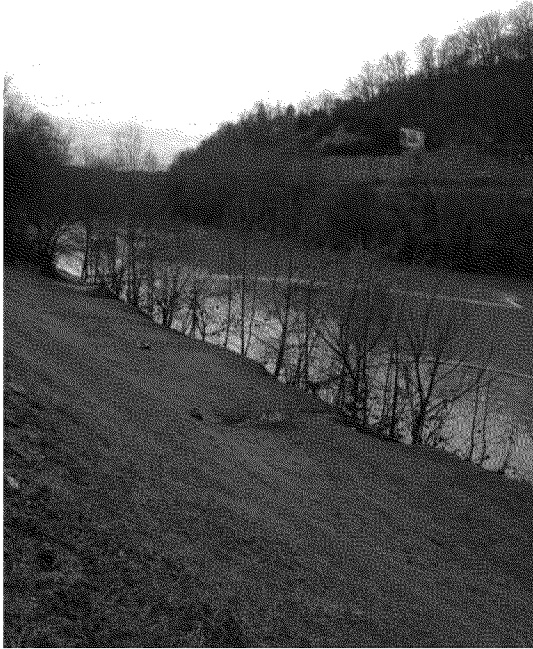
Photo No. IMG_1093; Taken on 01/11/14 at 12:21 hours by
START GN. River boom deployed in Elk river.

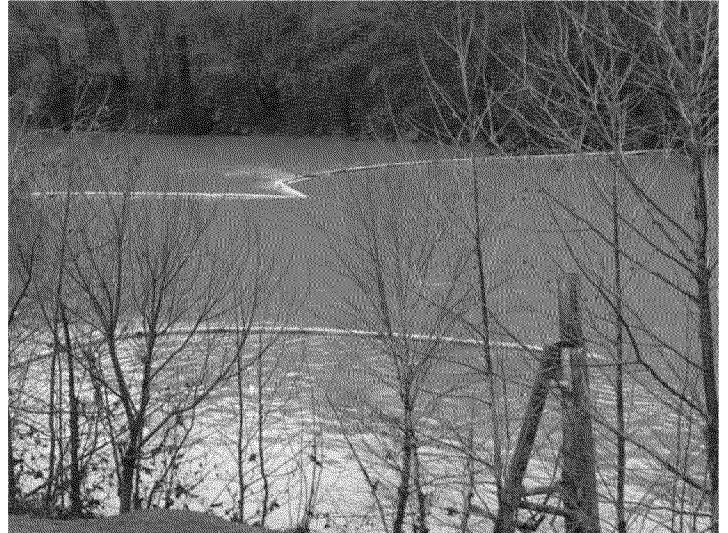
Photo No. IMG_1094; Taken on 01/11/14 at 12:22 hours by
START GN. River boom deployed in Elk river.

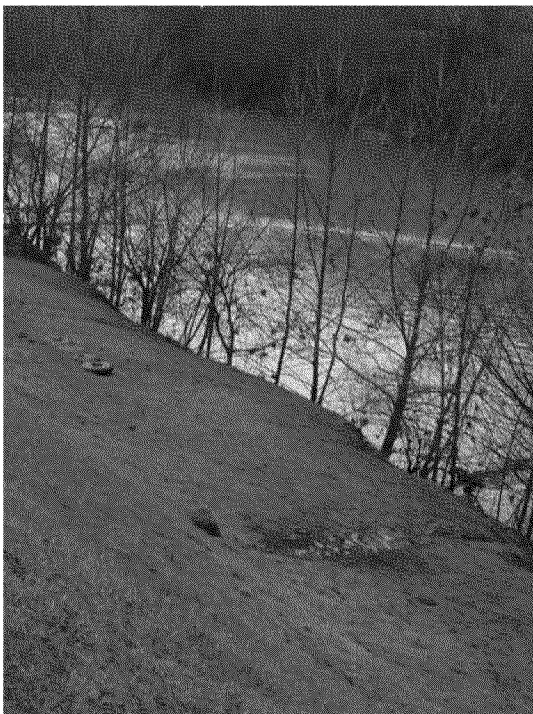
Photo No. IMG_1095; Taken on 01/11/14 at 12:24 hours by
START GN. River boom deployed in Elk river.

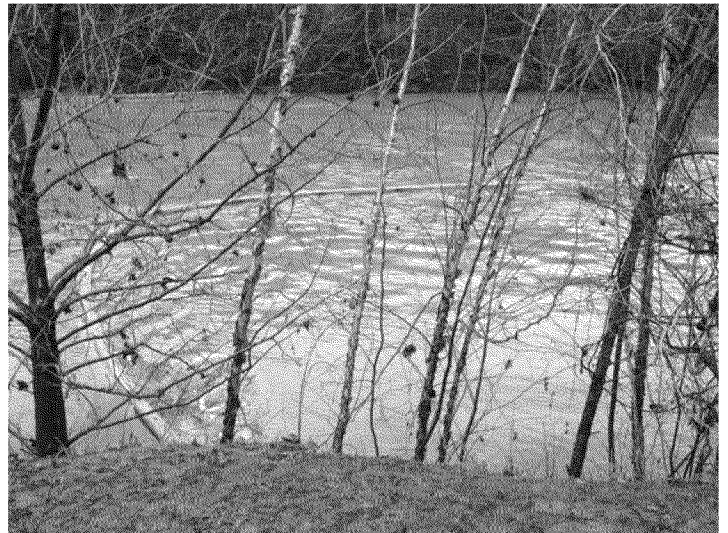
Photo No. IMG_1096; Taken on 01/11/14 at 12:24 hours by
START GN. Debris collected in river boom in Elk River.

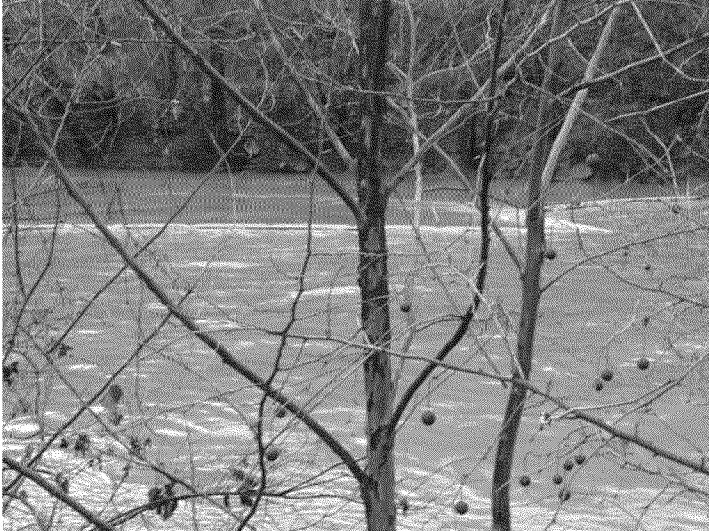
Photo No. IMG_1097; Taken on 01/11/14 at 12:25 hours by START GN. River boom deployed in Elk river.

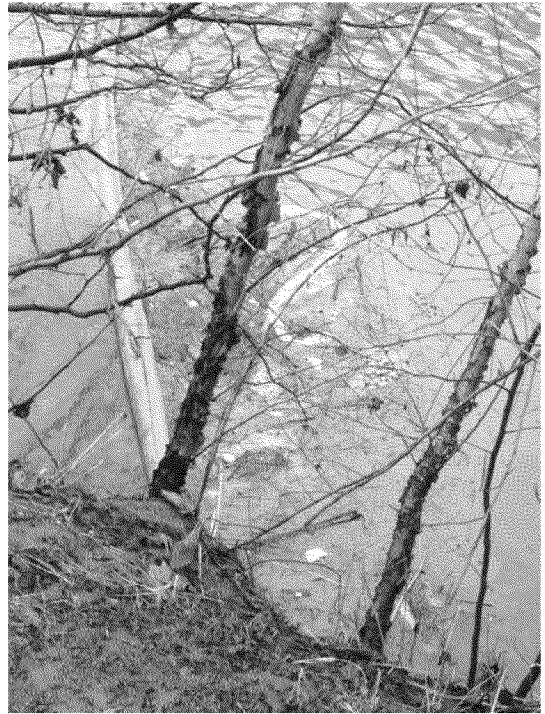
Photo No. IMG_1098; Taken on 01/11/14 at 12:25 hours by START GN. Debris and MCHM product collected in river boom in Elk River.

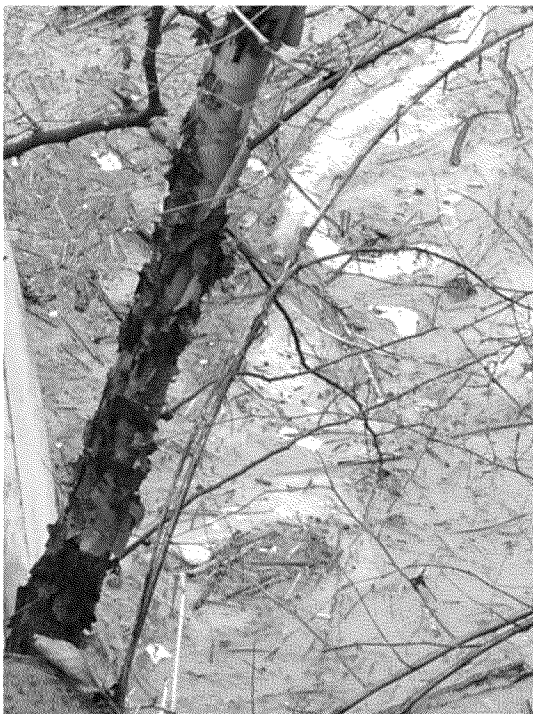
Photo No. IMG_1099; Taken on 01/11/14 at 12:26 hours by START GN. Debris and MCHM product collected in river boom in Elk River.

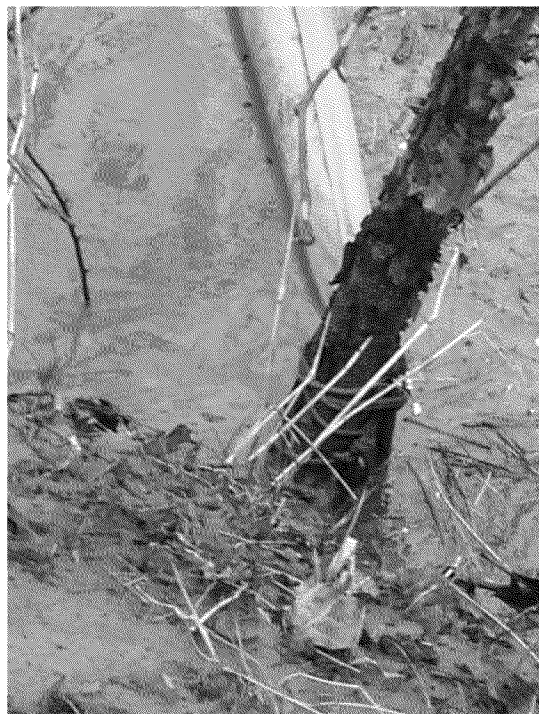
Photo No. IMG_1101; Taken on 01/11/14 at 12:29 hours by START GN. Debris and MCHM product collected in river boom in Elk River.

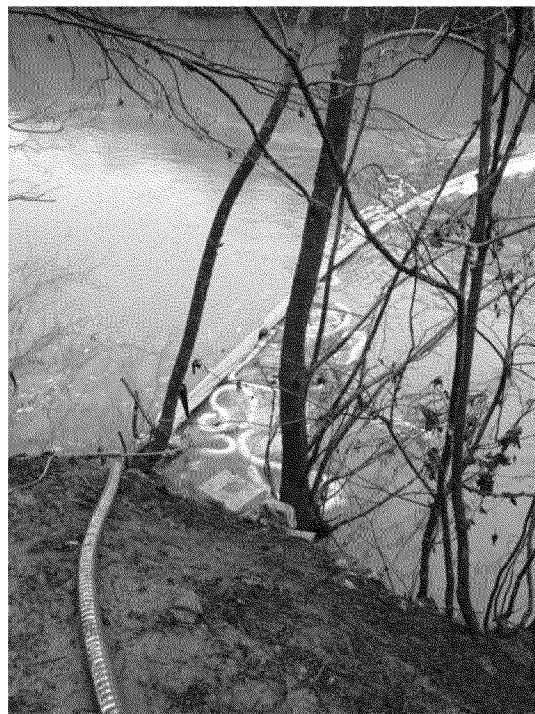
Photo No. IMG_1102; Taken on 01/11/14 at 12:29 hours by START GN. Debris and MCHM product collected in river boom in Elk River.

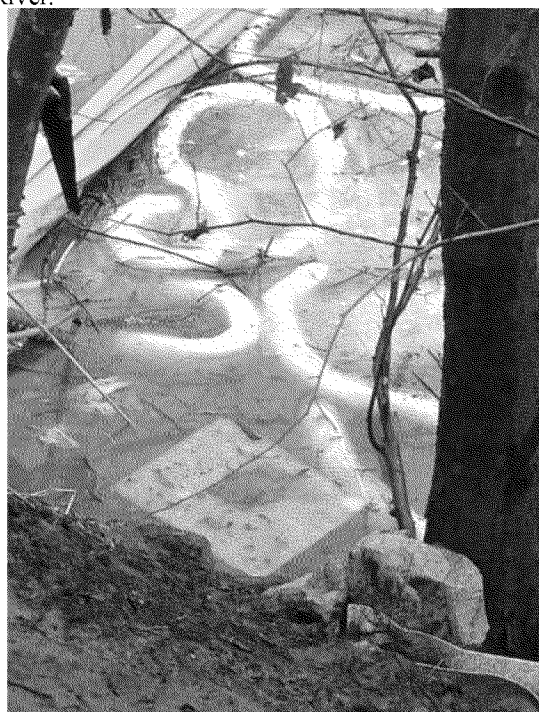
Photo No. IMG_1103; Taken on 01/11/14 at 12:29 hours by START GN. Debris and MCHM product collected in river boom in Elk River.

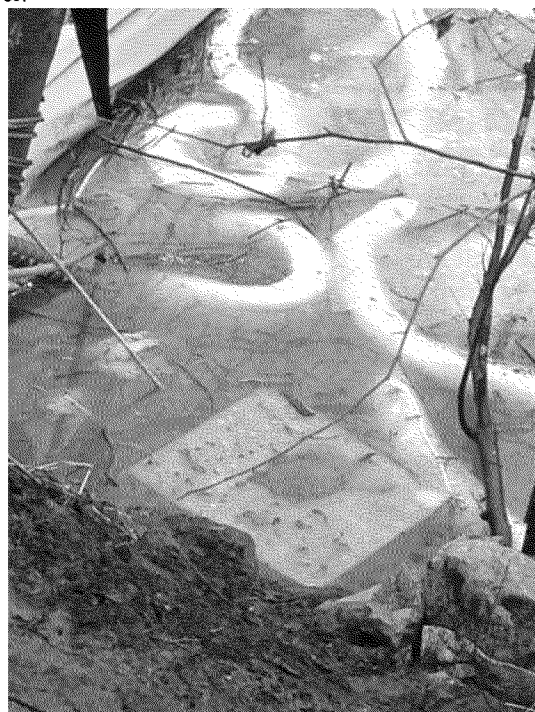
Photo No. IMG_1104; Taken on 01/11/14 at 12:34 hours by START GN. Debris and MCHM product collected in river boom in Elk River.

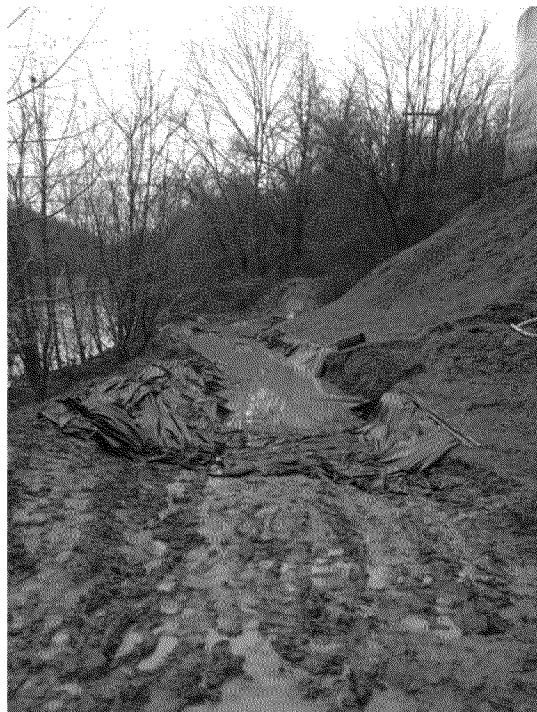
Photo No. IMG_1105; Taken on 01/11/14 at 12:34 hours by START GN. Containment trench lined with poly, but not to full extent of area under water.

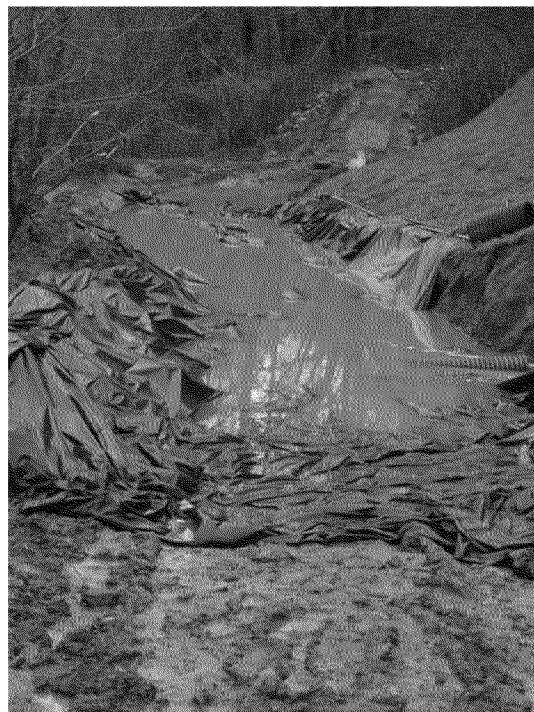
Photo No. IMG_1106; Taken on 01/11/14 at 12:35 hours by START GN. Containment trench lined with poly.

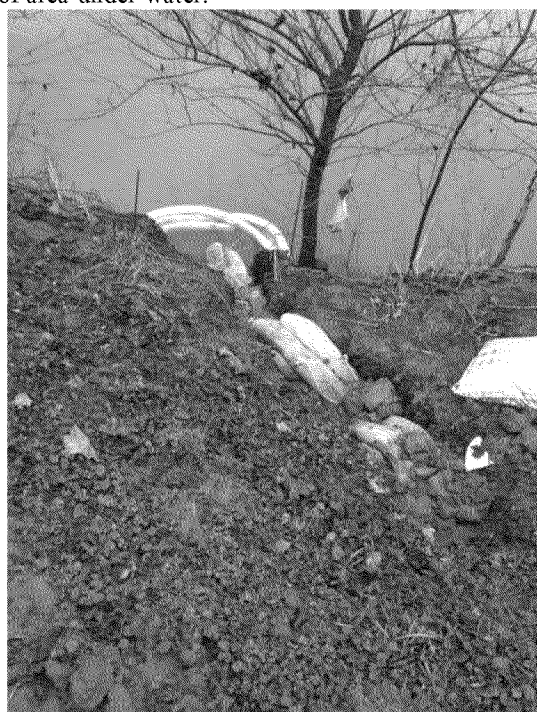
Photo No. IMG_1107; Taken on 01/11/14 at 12:35 hours by START GN. Drainage path to River from storm water outlet. No water flow in ditch.

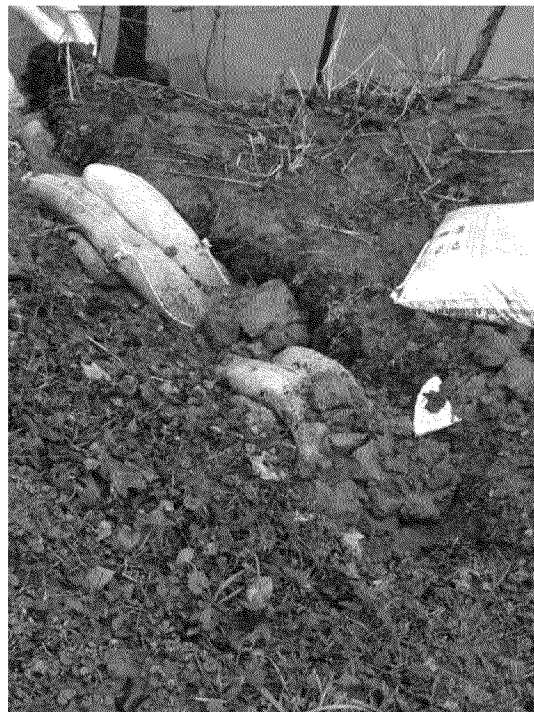
Photo No. IMG_1108; Taken on 01/11/14 at 12:39 hours by START GN. Drainage path to River from storm water outlet. No water flow in ditch.

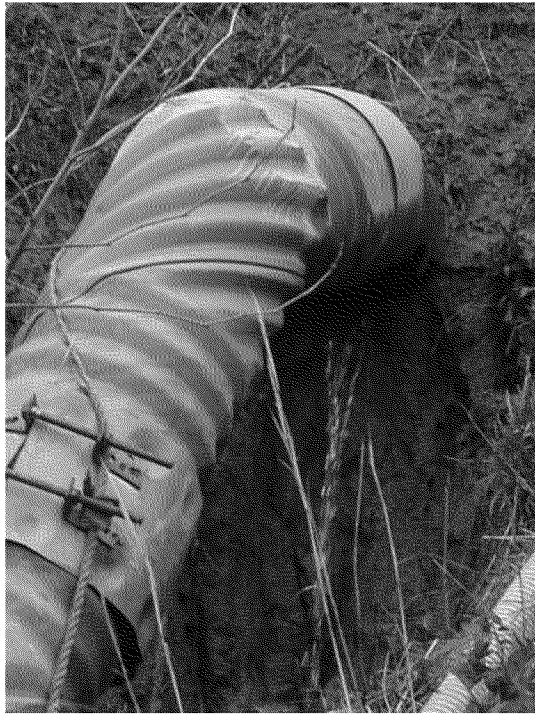
Photo No. IMG_1109; Taken on 01/11/14 at 12:40 hours by START GN. stormwater leaking from pipe on hillside below tank farm.

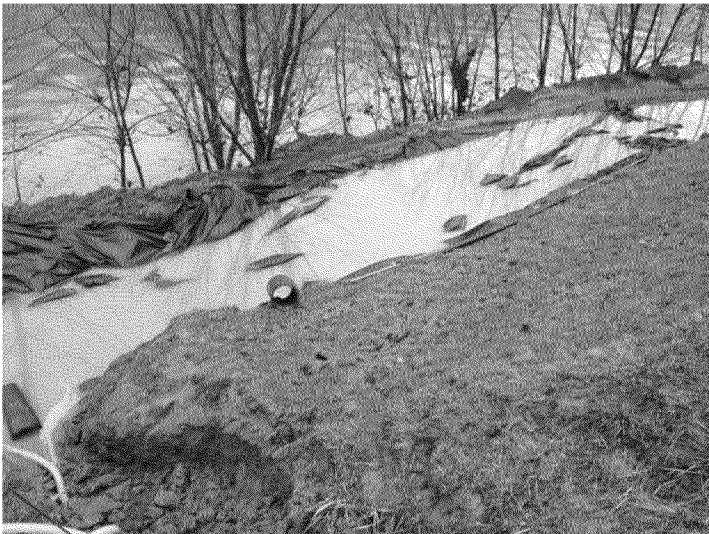
Photo No. IMG_1111; Taken on 01/11/14 at 12:40 hours by START GN. Water accumulated in trench/sump.

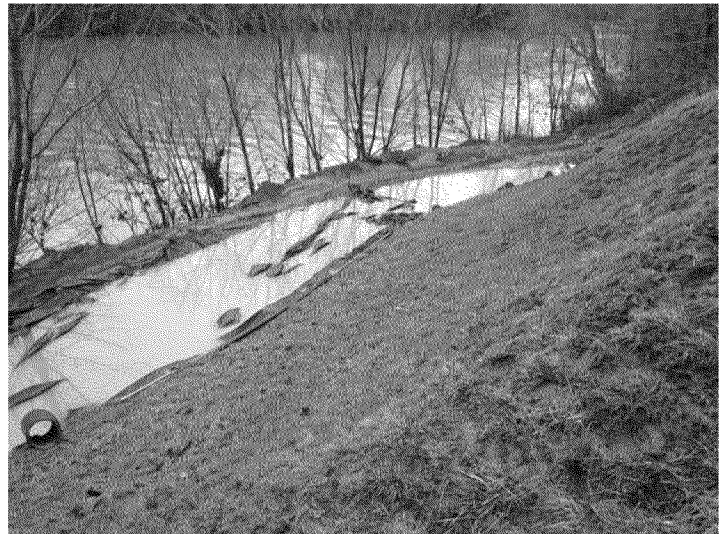
Photo No. IMG_1112; Taken on 01/11/14 at 12:40 hours by START GN. Water accumulated in trench/sump.

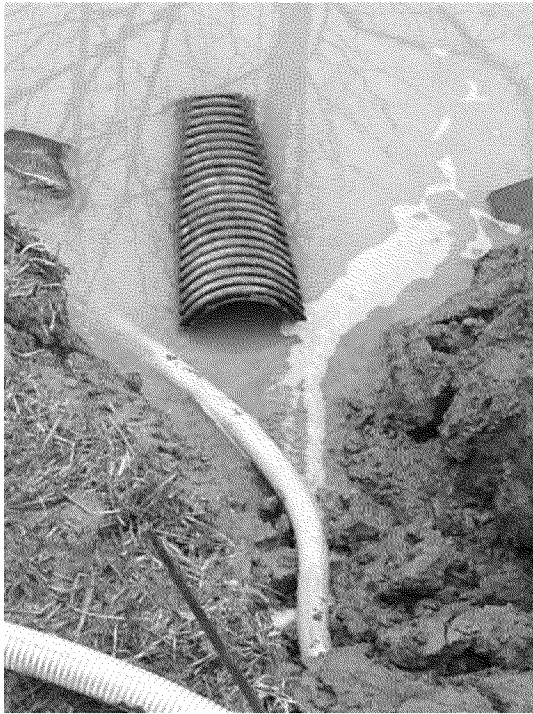
Photo No. IMG_1113; Taken on 01/11/14 at 12:42 hours by START GN. Water flowing into collection trench/sump.

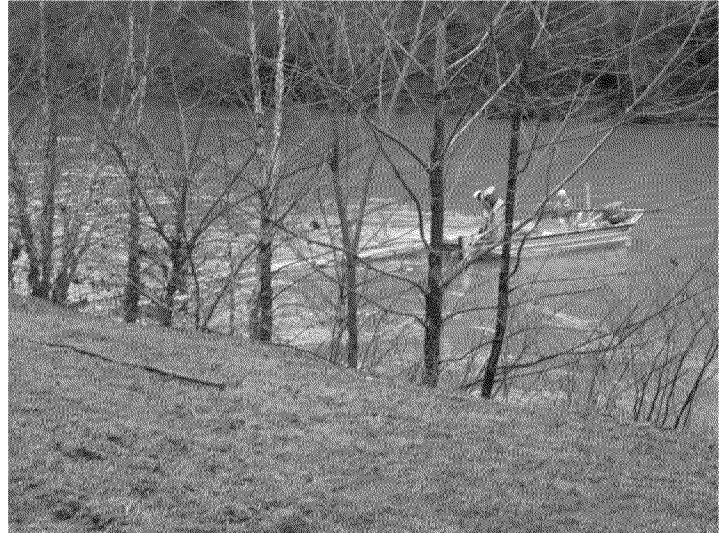
Photo No. IMG_1114; Taken on 01/11/14 at 13:01 hours by START GN. Clean Harbors deploying river boom.

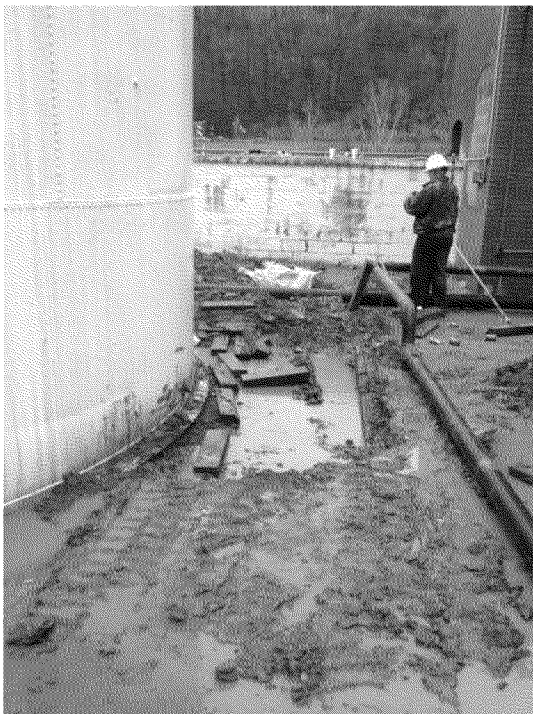
Photo No. IMG_1115; Taken on 01/11/14 at 13:01 hours by START GN. Cinder block containment wall.

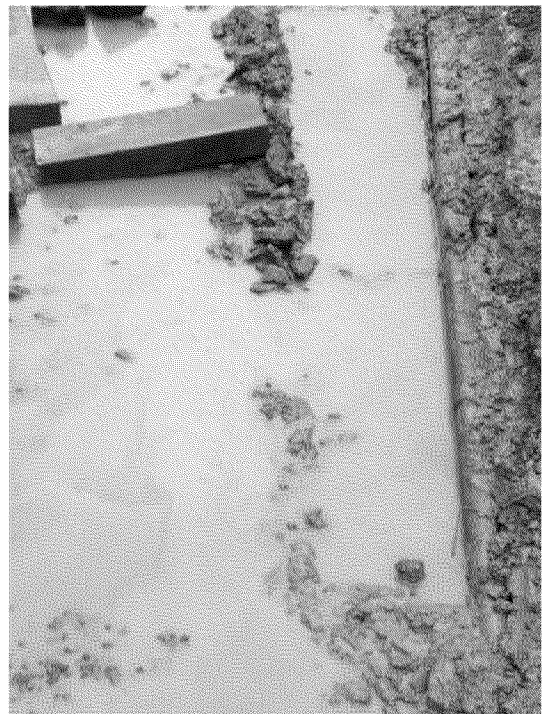
Photo No. IMG_1116; Taken on 01/11/14 at 13:07 hours by START GN. Water within tank containment area.

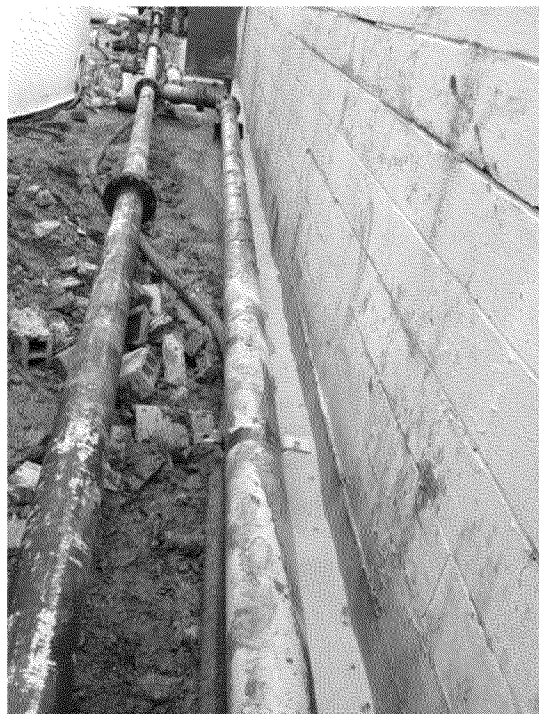
Photo No. IMG_1117; Taken on 01/11/14 at 13:07 hours by START GN. Bentonite placed along cinderblock containment wall in tank farm where MCHM was reported to have released.
